New Diverging Diamond Interchange at Junction 52 Odense SV

Presentation of Road Safety Audits 2016-2018 by
Morten Klintø Hansen, Danish Road Directorate

- NVF Lillehammer, September 2019

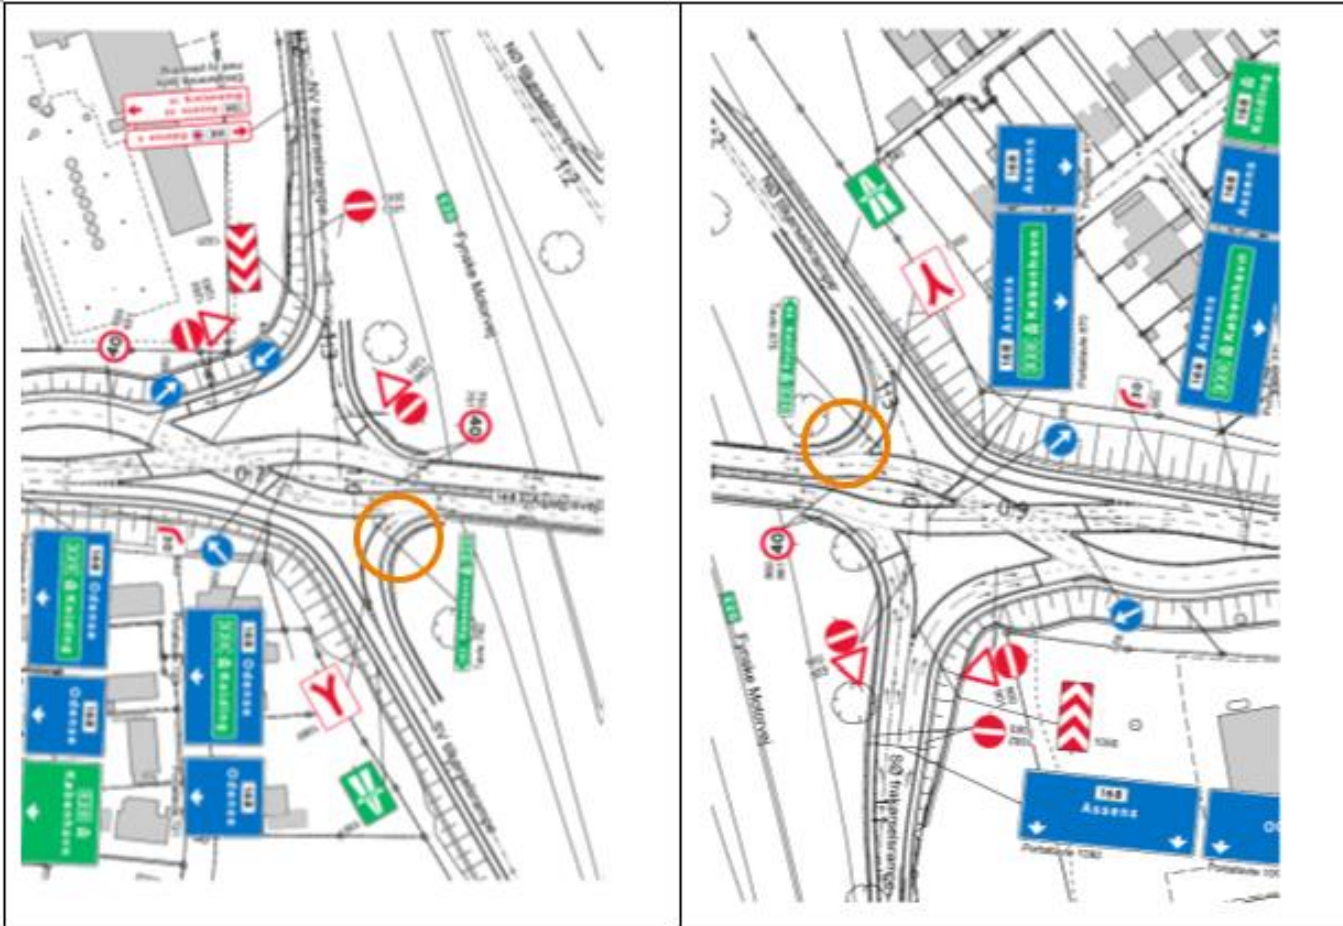
Sharp left turns from motorway bridge

- Problem
 - Sharp horizontal curve radii for left turning towards entry ramps at end of the motorway bridge, max. speed of 30 km/h possible, no left turning lane, risk of too high approach speeds, especially in non-peak hours. This increases the risk of rear-end collisions and single vehicle accidents.
- Recommendation
 - Increase curve radii, preferably to allow for 40 km/h turning speeds.

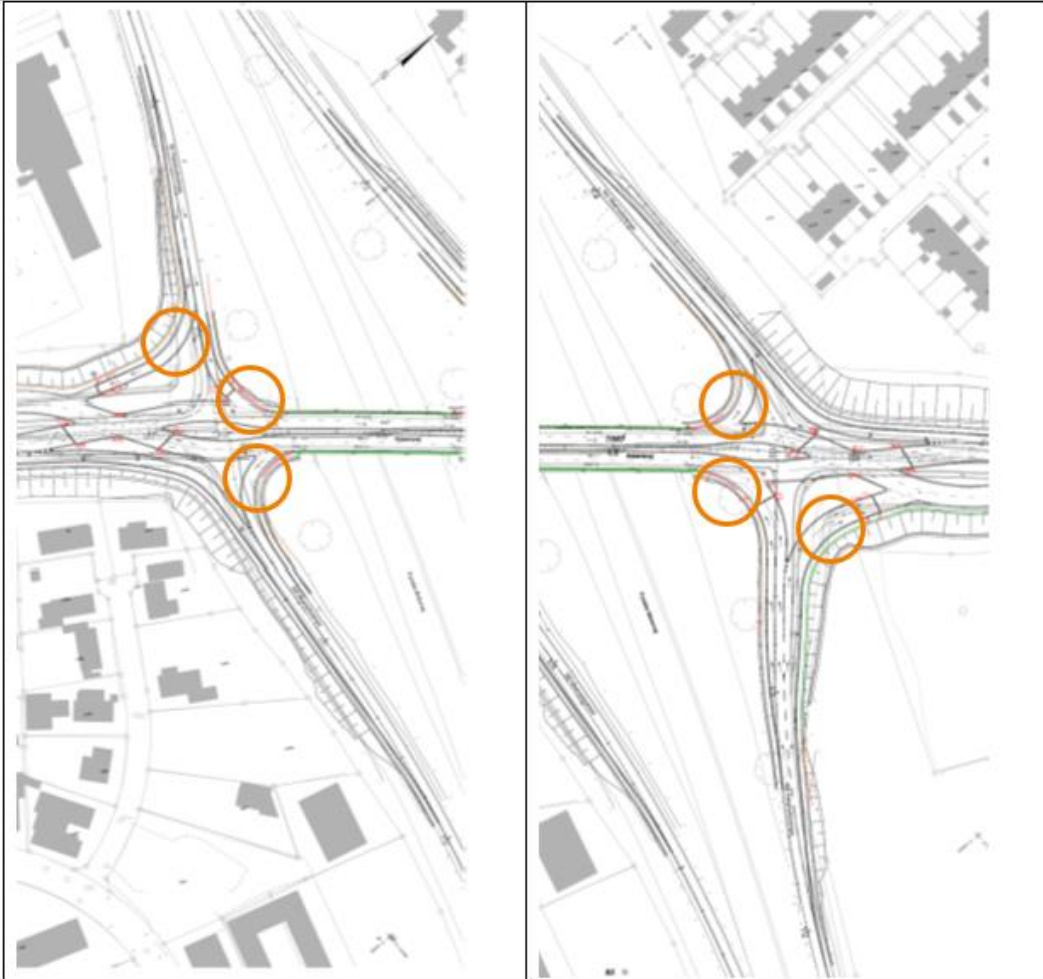
Lack of stop sight in sharp curves

- Problem
 - In a number of sharp horizontal curves there is insufficient stop sight at the planned 40 km/h speed limit, due to combination of curve radii and new crash barriers. Especially on the exit ramps from the motorway there is a risk of much higher approach speeds. The lack of stop sight increases the risk of rear-end collisions and collisions with lost goods, etc.
- Recommendation
 - The project should provide stop sight at the design speed, as minimum the planned 40 km/h speed limit. Otherwise the speed limit should be lowered accordingly.

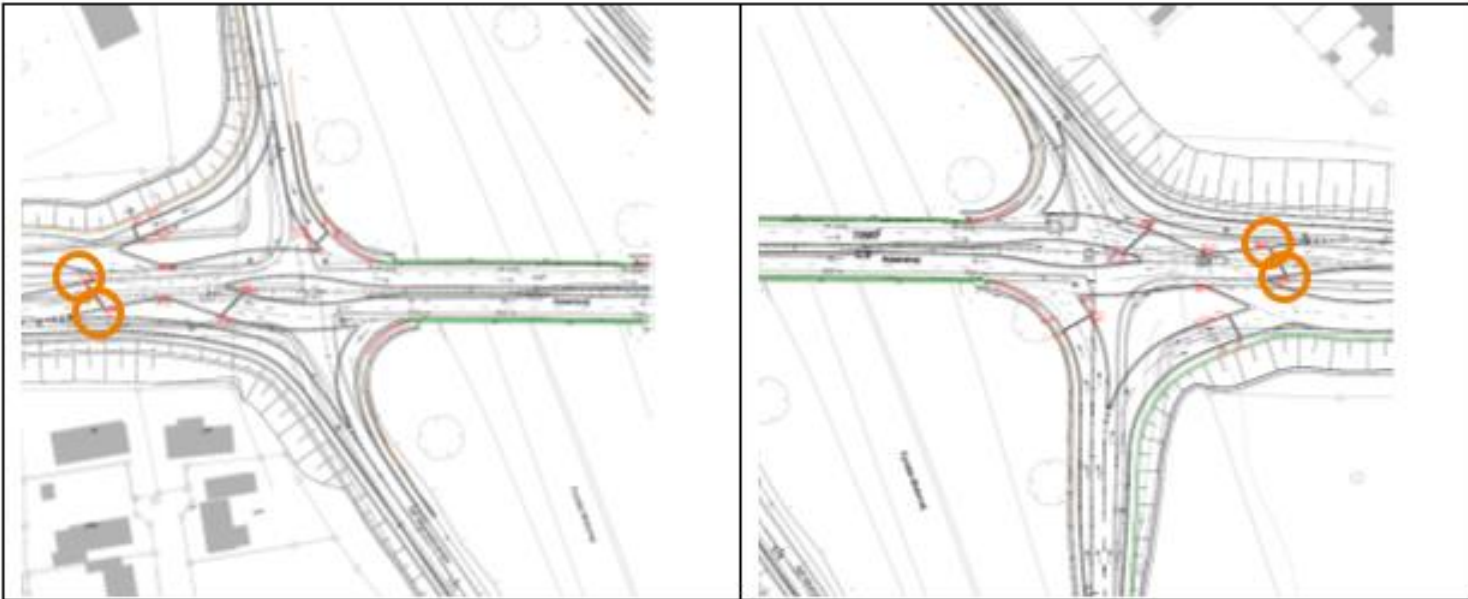
Unintentional right turns in traffic lights

- Problem
 - Despite planned 3-arrow signals, markings and refuges there is a risk that traffic makes "normal" but here unwanted right turns on approach to motorway bridge on Assensvej – against the oncoming traffic from bridge.
- Recommendation
 - Set up right-turn prohibition signs in approaches to traffic lights, direction towards bridge.

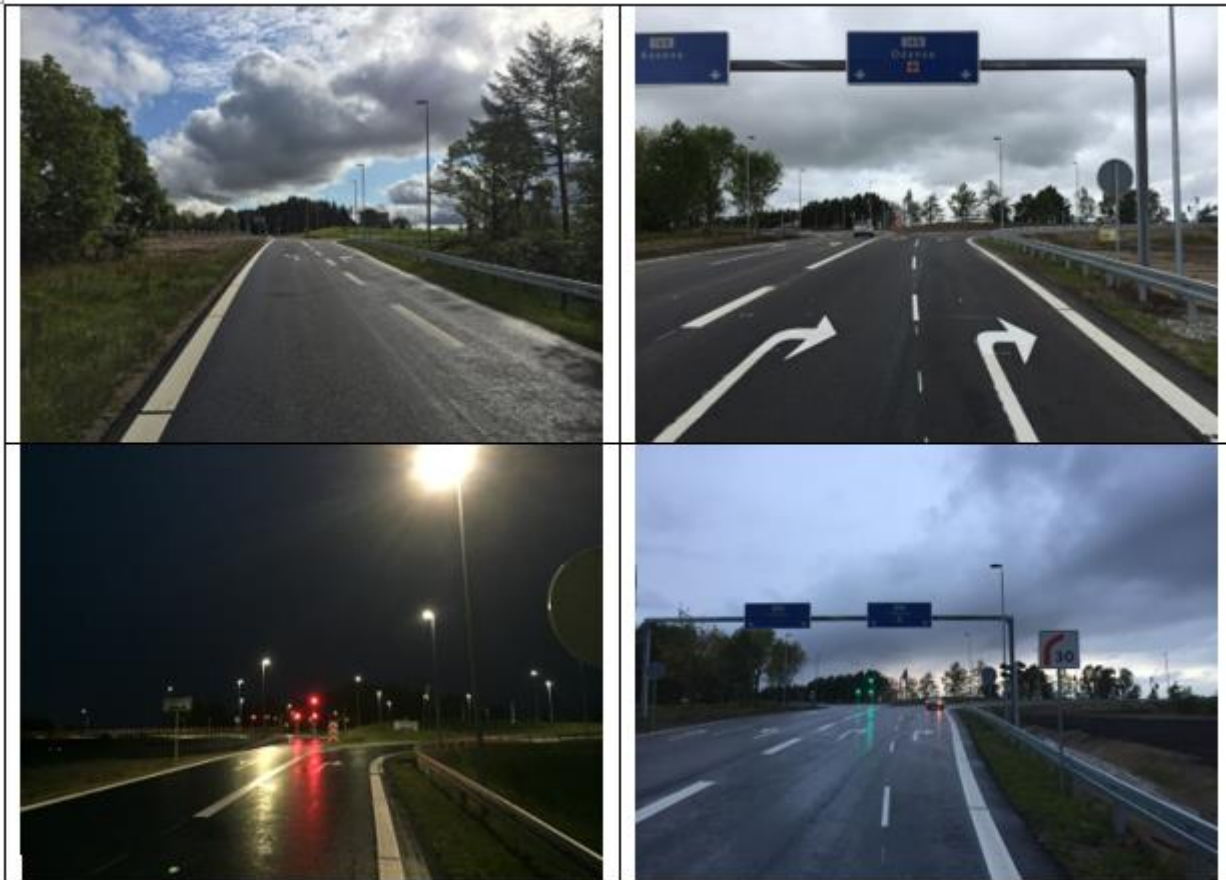
Missing background markings

Fotos hhv. 20. september og 4. oktober 2017 af frakørselsramper (SV til venstre og NØ til højre).

- The exit ramps end in sharp left and right turning curves at the traffic light on Assensvej. The right turning curves are long, with limited sight, regulated with a recommended speed limit of 30 km/h.
- There is a risk of high approach speeds and of underestimating the right curve and overlooking the following traffic lights, especially in the 2 lane right curve.

- Set up background markings with directional arrow signs.

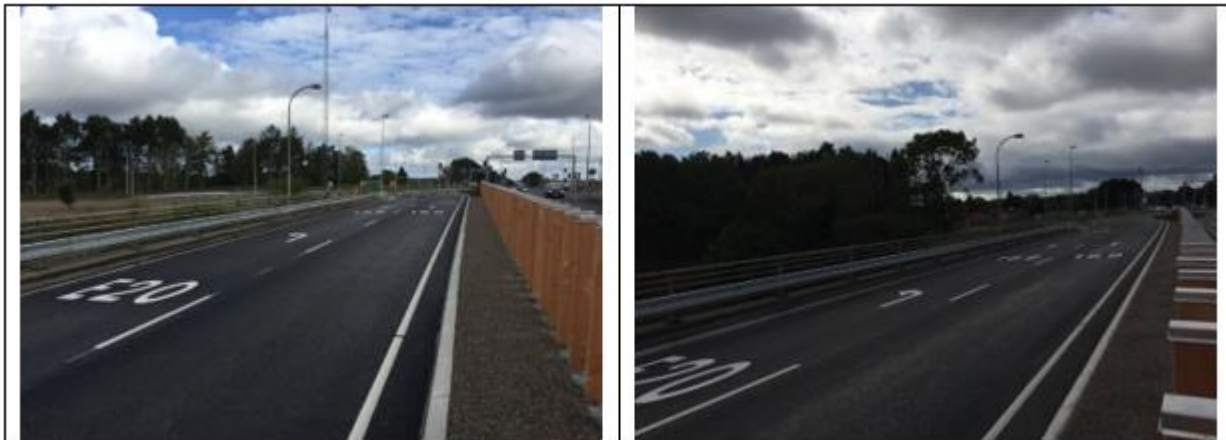
Misleading arrow markings on bridge

Fotos 20. september 2017 af vognbanepile på motorvejsbro på Assensvej, hhv. mod nord og syd.

- Problem
 - From project step 3 to 4 the planned arrow road markings on the motorway bridge were changed. The left lane of the dual carriageway is now marked with alternately left and straight through arrows. This can be misleading, and cause sudden braking and lane shifting at exits to the entry ramps as the left lane is a combined through-left turning lane.
- Recommendation
 - Change the arrow road markings to the previously planned combined arrows.

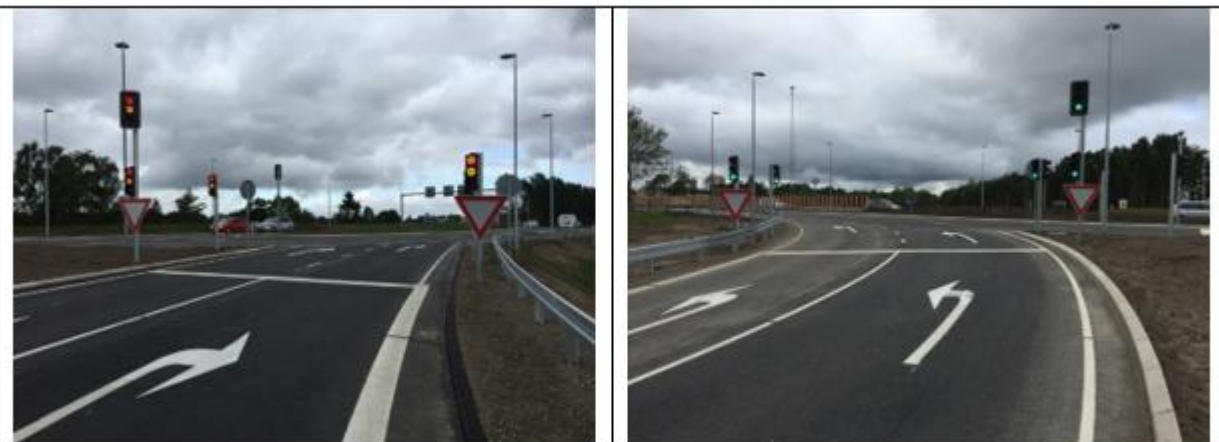
Placement of lanterns and signs

Fotos 20. september 2017 med eksempler på signallanterner (og B11 tavler) for tæt på kørebanen.

- Problem
 - Certain signal lanterns and road signs are placed too near the carriageway. This partly increases the risk of traffic colliding with the equipment, partly - after damages to the equipment - increases the risk of causing more severe accidents due to missing or misleading traffic regulation.
- Recommendation
 - Review and adjust the placement of signal lanterns and road signs in accordance with the road marking standards, both horizontally and vertically.

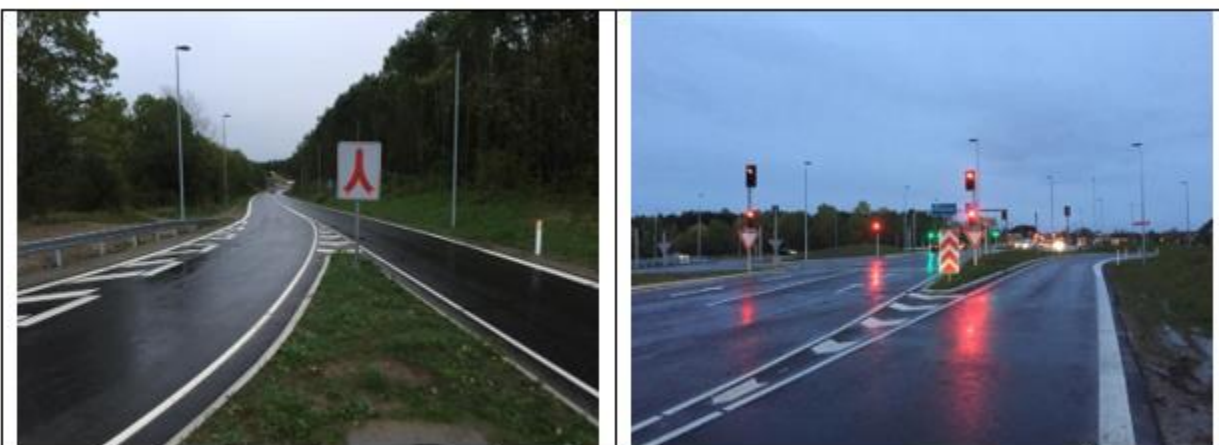
Fotos 4. oktober 2017 med eksempler på B15 flettetavle og N43 Spidsmarkering for tæt på kørebanen.
