OPTIMISATION OF WINTER MAINTENANCE ON PEDESTRIAN AND CYCLING PATHS - CASE STUDY RR 110

Nordic Road Safety Forum 13-14.10.2022, Copenhagen

2. STARTING POINTS FOR THE RESEARCH AND ITS OBJECTIVES

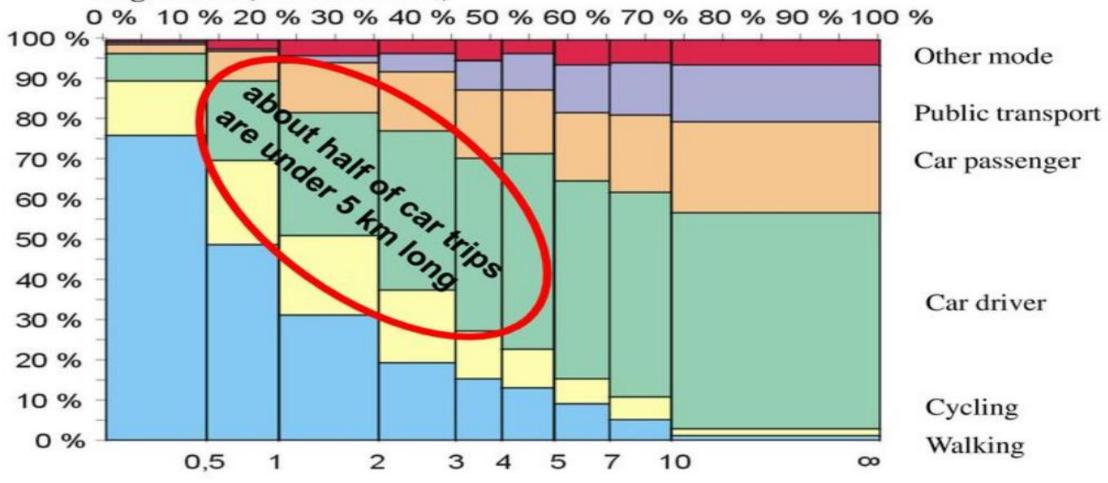
Modal split of trips by trip length (vertical axel) and share of trips in each length class (horizontal axel)

N=33812 me Trip length km (width of bar = share of trips in length class)

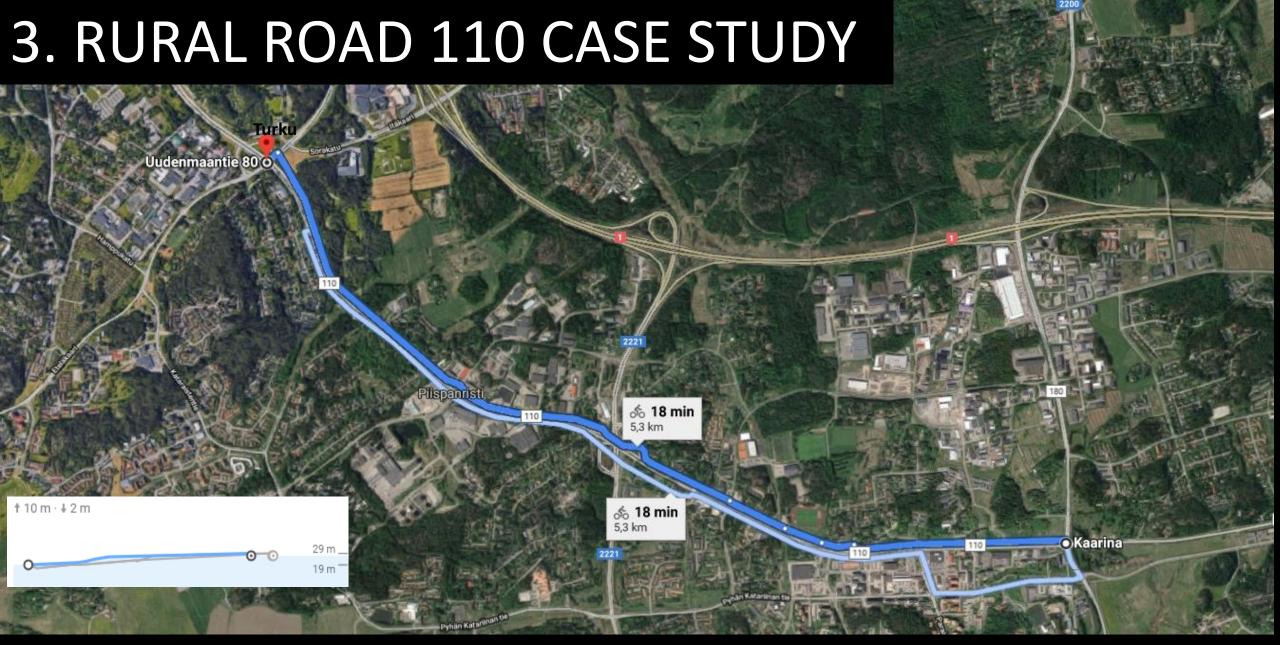
The target research area of Rural road 110 is highlighted in blue. Report phase 1: https://urn.fi/URN:ISBN:978-952-314-706-5

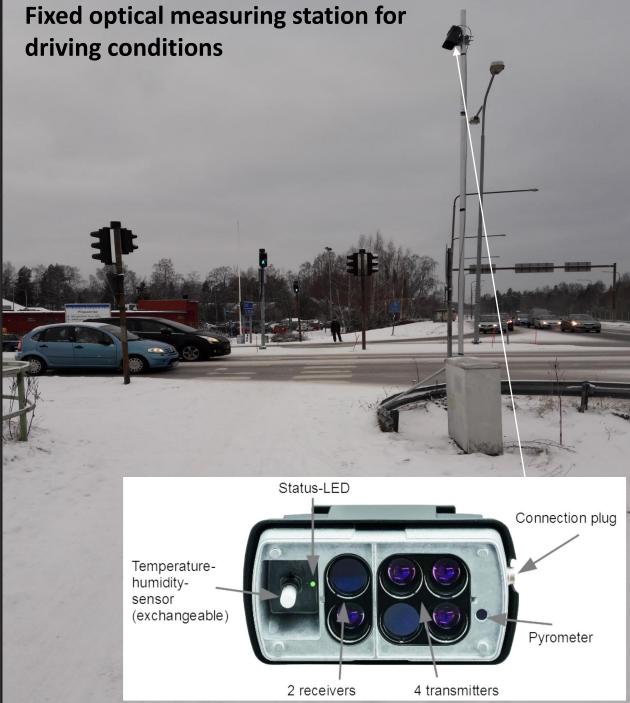
Road condition Snow

Friction 0,29

Road temperature -5,77 °C

Dewpoint temperatur -7,71 °C

Waterfilm height 469,20 µm

The mobile Marwis device, which was mounted in a car, collected the same road conditions data as the Starwis device, but its data collection targets were also the pedestrian and cycling paths across the research area (5 km). A measurement drive was carried out whenever there was a significant change in the weather.

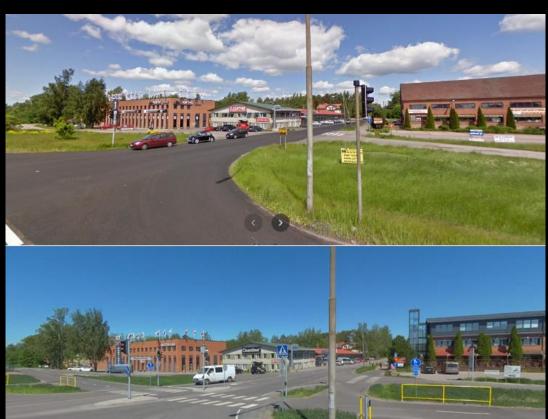
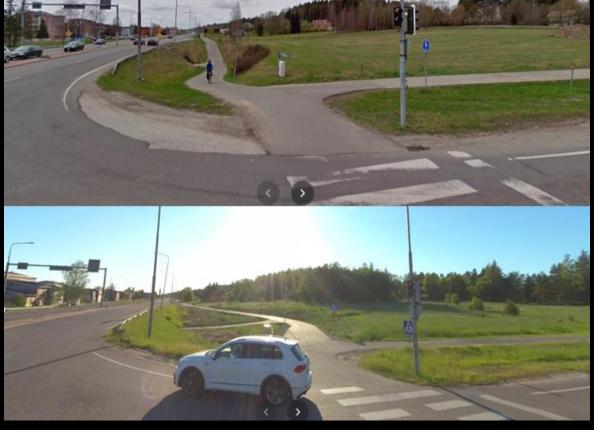
Before 2018 and after 2021. Walking and cycling paths have now been rebuilt in line with the phase 1. recommendations. They were completely reasphalted and the northern path was widened from 3 to 5 m.

Underpasses and interchanges were made safer and easier to maintain. € 1.7 million was spent on pedestrian and cycling path improvements (€ 170 000 /km).

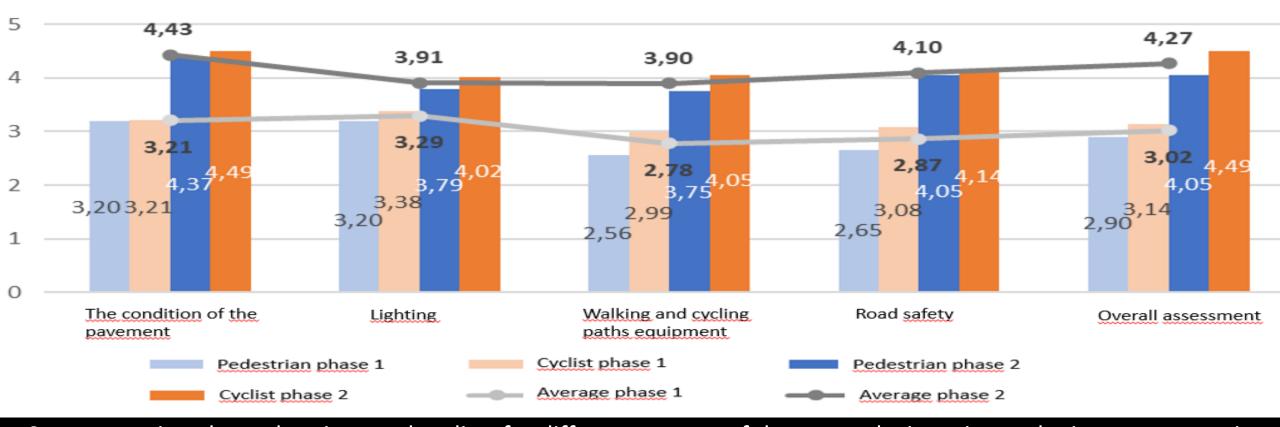
How do you evaluate following characteristics of the walking and cycling paths between Turku and Kaarina?

Scores are given by pedestrians and cyclists for different aspects of the research site prior to the improvements in 2018 and since then in 2021.

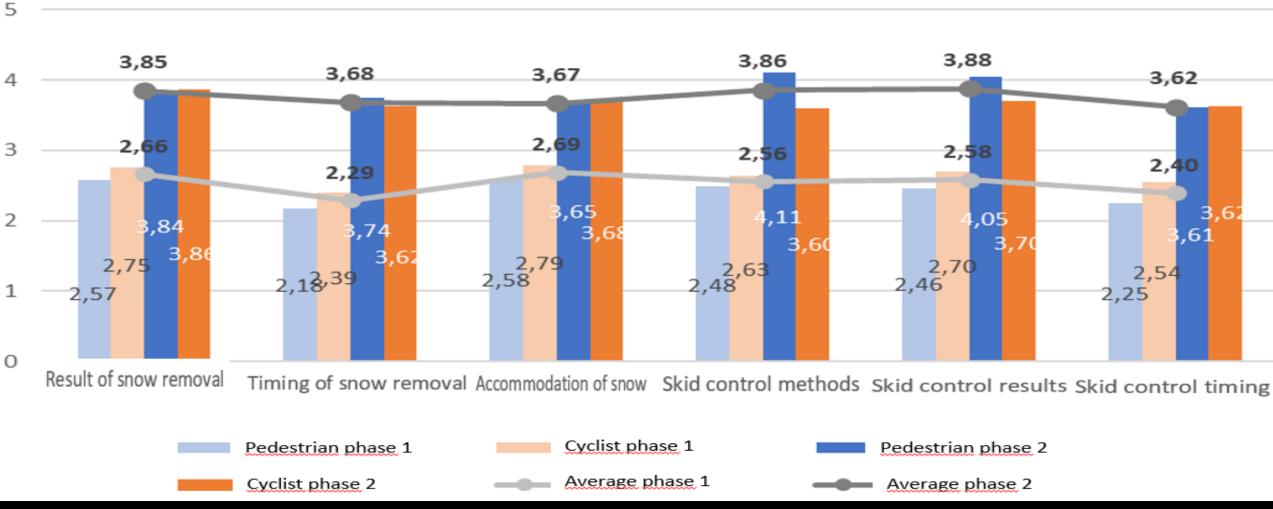
How do you evaluate following parts of winter maintenance on the walking and cycling paths between Turku and Kaarina? (1=very poor, 5=very good)

Scores were given by pedestrians and cyclists for different aspects of the winter maintenance of the research site before the improvements in 2018 and since then in 2021.

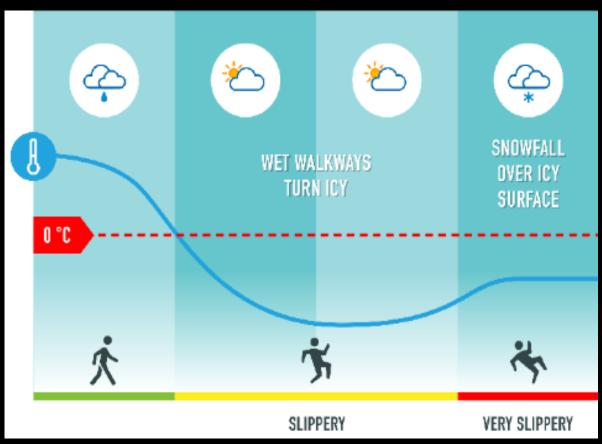
Scenario 1: before the temperature drops below zero, the weather is wet; either from rain or the streets are wet from melting snow. The water then turns into a slippery icy surface. A layer of fallen snow on the ice further reduces the grip levels of the surface.

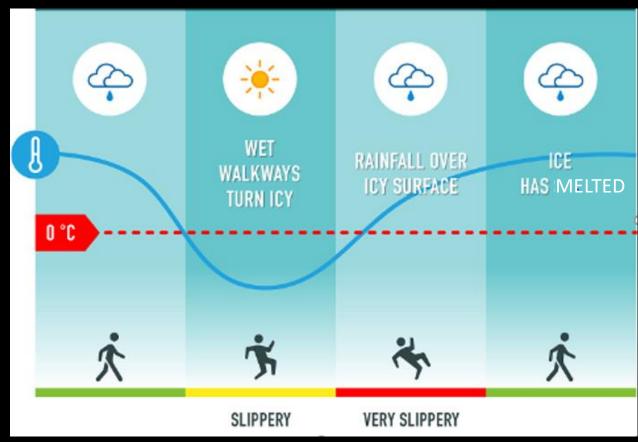
Scenario 2: the temperature falls below zero degrees Celsius for a short period of time, usually between morning and midday, turning the water on the paths into ice. As the temperature increases further, the ice starts to melt, creating a layer of water on top of the ice, which further reduces the level of grip. Rainfall on the ice makes the surface even more slippery.

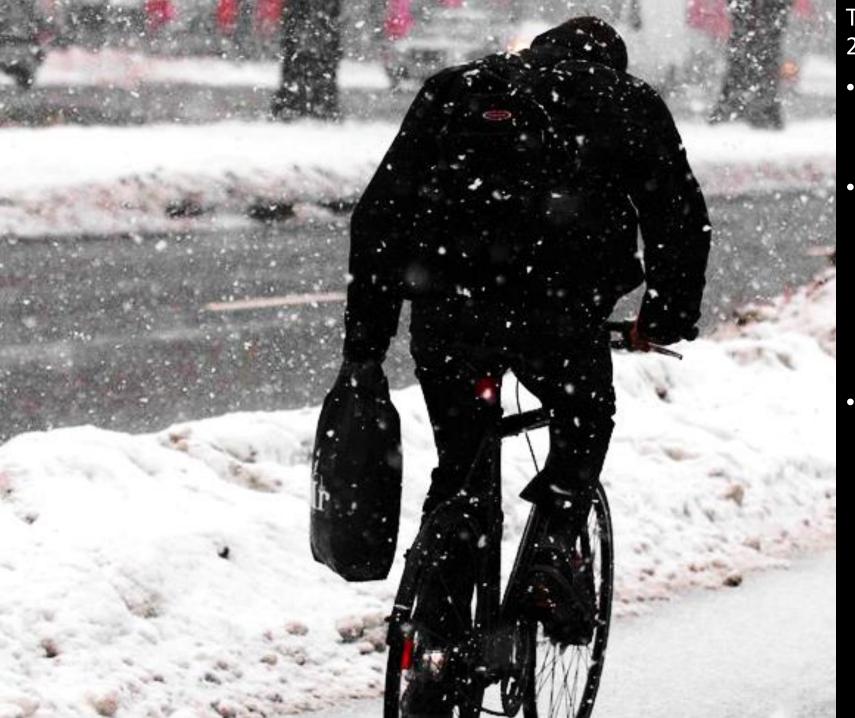
The data in the pilot project 2018-2021:

- cycling decreased by as much as 85% in winter compared to the busiest summer months
- the results of the study support those obtained in previous studies, where improved winter maintenance was seen to have the effect of increasing commuting by bicycle in winter by up to 18% and reducing commuting by car by 6%
- The coronavirus pandemic did not discourage walkers and cyclists in the research site in the winter of 2021. The pandemic has had an effect in particular on the distribution of weekday and weekend journeys.
